Technical Bulletin: 1/11/2005

Changing in the GPS Antenna placement on the DataStorm F1

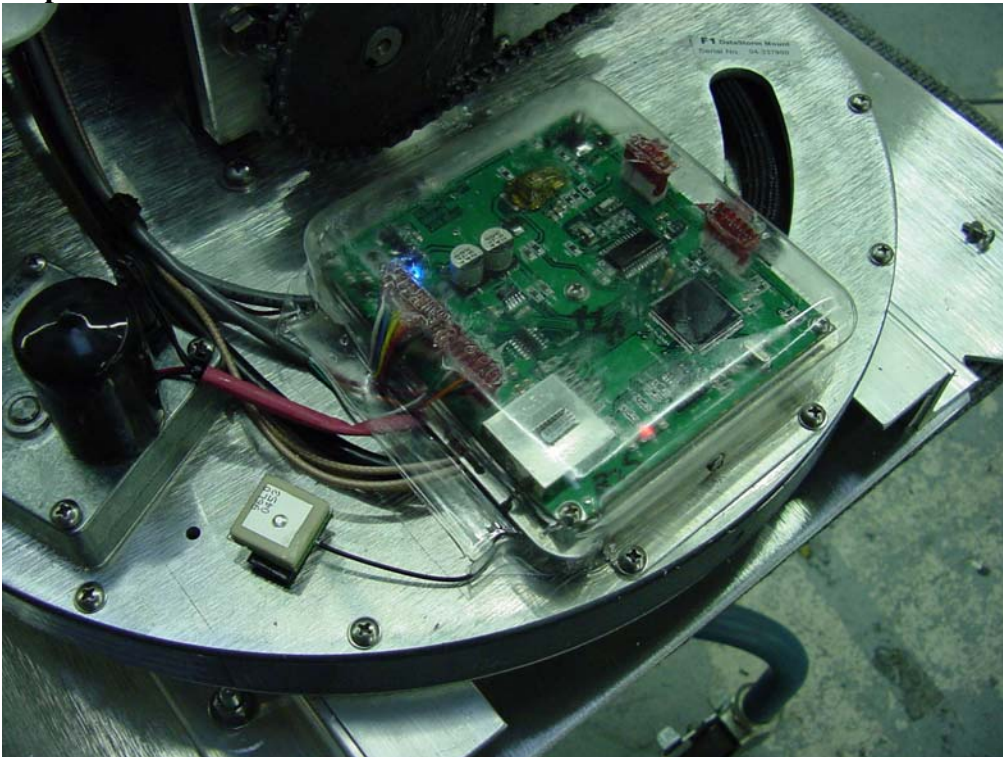
Step 1

After you have removed the White plastic base mount cover you will notice the antenna has been affixed with Velcro to the left of the UCU.
